## What Home Inspectors Need to Know About

# SLATE ROOFS

Joseph Jenkins

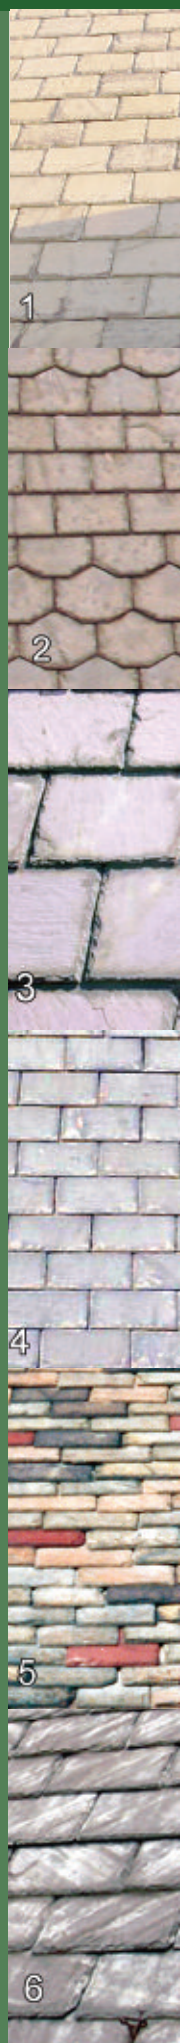
*1) a 70-year-old Vermont unfading green slate; 2) 110-year-old Pennsylvania black slate (a harder variety); 3) 90-year-old Vermont purple slate; 4) 100-year-old Buckingham, Virginia, slate; 5) a mix of sea green slate (also known as semi-weathering green), Buckingham, and NY red slate; 6) Chapman (PA) slate with its characteristic diagonal striations.*
